Field identification and mitigation of geosynthetic clay liner seam separation in a tailings impoundment composite liner system

P.E. Kowalewski, PE, K.S. Sessions, PE, J.W. Knudsen, PE, A.K. Butler, PE
Tierra Group International, Ltd., Elko, Nevada, USA

ABSTRACT: The use of geosynthetic clay liners (GCLs) as a component of composite liner systems in landfills, ponds, heap leach facilities, and tailings impoundments has increased significantly over the past 5 to 10 years. Field observations (Thiel and Richardson, 2005 and Koerner and Koerner, 2005) and laboratory testing (Thiel et al., 2006) have indicated that under specific unconfined and exposed conditions, seam separation may potentially occur due to several different mechanisms, including tension necking or shrinkage due to repeated wetting and drying cycles. During the construction of a raise to an existing tailings storage facility in the western United States, it was suspected that the GCL secondary liner, installed during construction of the previous stage, experienced seam separation in a limited area. A field investigation was conducted to identify affected areas, a root cause analysis was completed, and measures were d

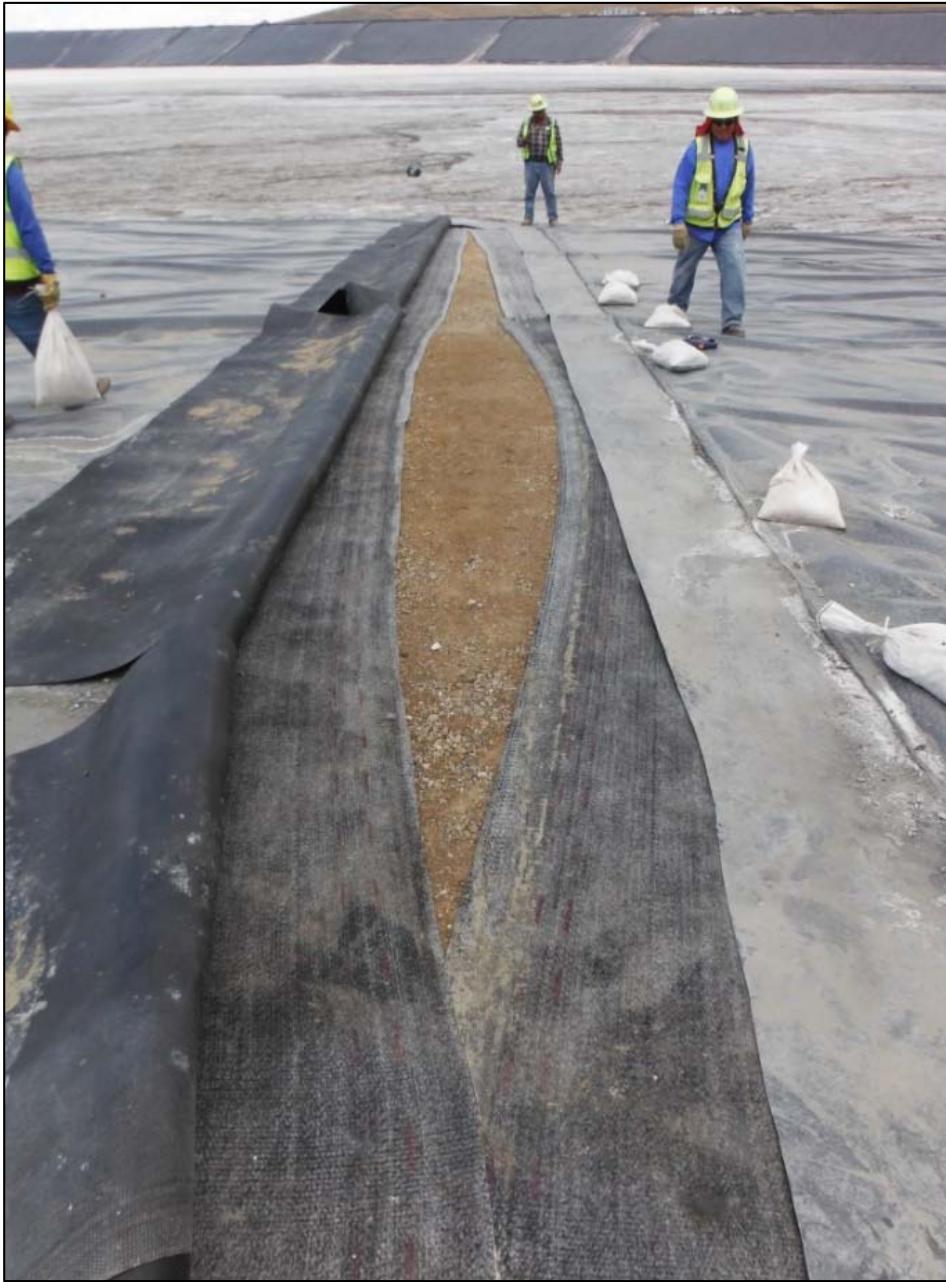
Photo 1. Example of Observed GCL Panel Separation

The Resident Engineer and Liner Installer walked the primary LLDPE liner along the approximate alignments and locations of the underlying GCL panel seams, as determined from the Panel Deployment Plans, to identify additional areas where seam separation may have occurred. Over 50 areas of potential seam separation were identified using the tactile and auditory identification methods. A total of 49 seam separation areas were positively identified after cutting open the primary liner and exposing the underlying GCL. Each separation was numbered, measured, and photographed prior to repairs. Panel separation was surveyed either prior to patching the primary LLDPE liner or after LLDPE patching by surveying marls on the liner showing the extents of the GCL separation (made by Resident Engineer at the time of patching). The seam separation widths

(measured at their maximum aperture) ranged from approximately 9 cm (3.6 in) to 101 cm (3.3 ft) and ranged in length from 0.3 m (1 ft) to 22.9 m (75 ft).

- Expose the entire GCL panel separation (seam) area;
- Measure the length and maximum width of panel separation;
- Survey the GCL panel separation extents (if surveyor was available); if surveyor was not available at the time of the repair, survey the extent of the LLDPE patch on the primary liner to identify approximate extents of the GCL repair;
- Install seaming bentonite at the edges of the GCL panel separation;
- Place a GCL patch over the panel separation area, with at least 15 cm (6 in) of overlap onto the existing GCL in every direction;
- Continuously heat-bond seam (tack) all edges of the GCL patch to the existing GCL; and
- Repair the primary LLDPE liner and perform installation QC measures according to the Project Construction Documents.

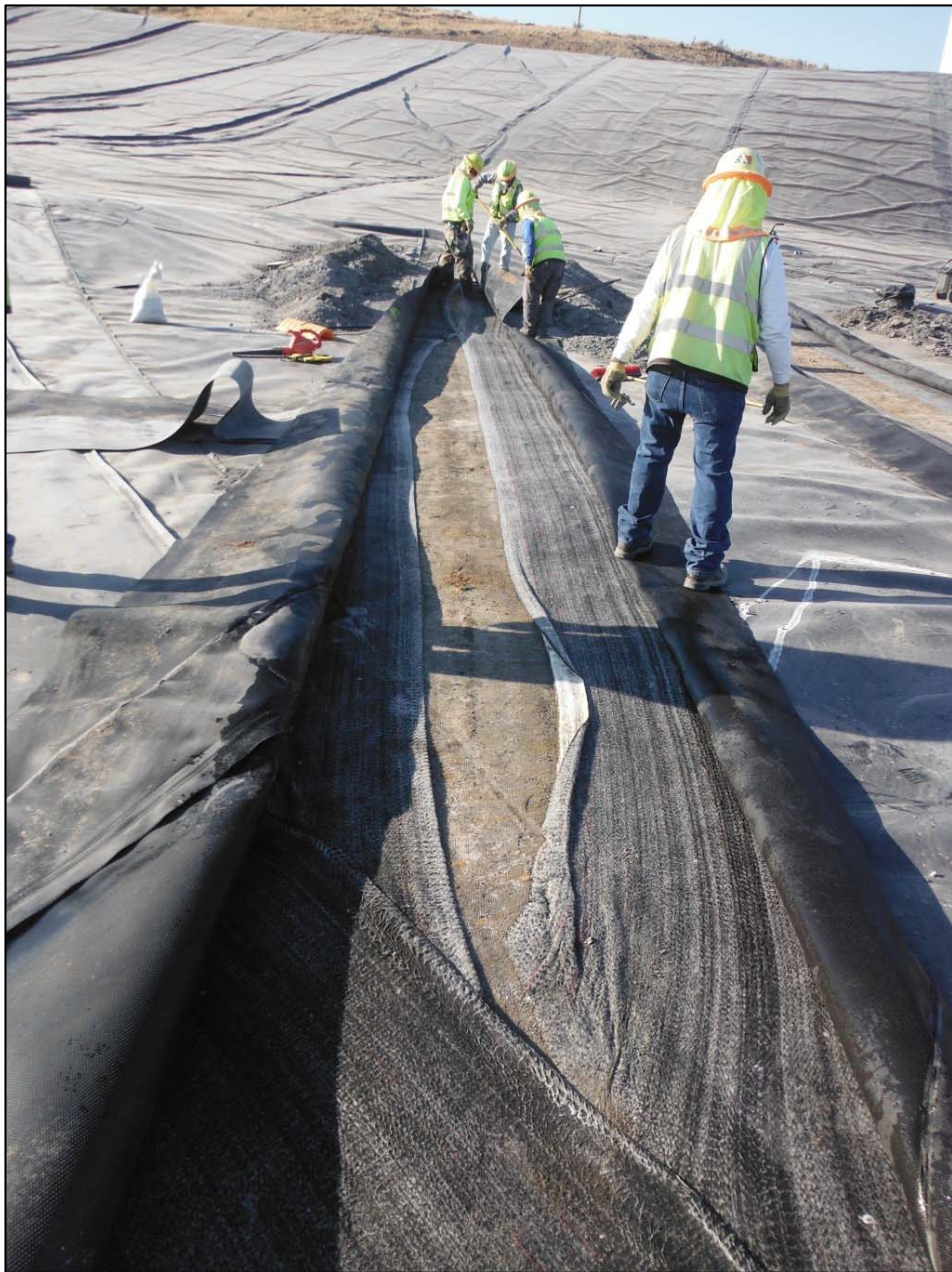
The observation that the seams did not appear to be separated where an adequate heat-bonded seam (tack) was present (Photo 2) and incorporated into the field repair method used on the identified separations.

Photo 2. GCL Panel Separation (Note Lack of Separation at Heat Bond)
