Cerro Santa Rosa tailings dam: Storage capacity increased using a unique mechanically stabilized earth design.

J.M. Purdy & M.L. Fuller

Vector Colorado, LLC, Golden, Colorado, USA

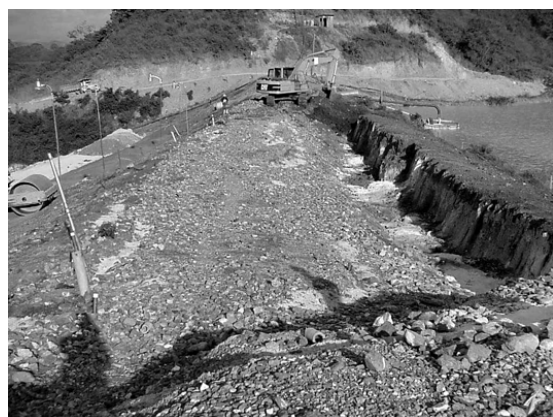
Figure 1. Slope failure scarp along the Phase II crest of the Cerro Santa Rosa tailings dam

In early October 2000, during hurricane Keith longitudinal depressions developed on the dam and control points on the dam began to indicate movement. By 10 October major longitudinal and transverse fractures (up to 9 m long and 0.6 m deep) had developed in the dam. The crest reportedly dropped 1.5 m and expansion of the dam slope was observed indicating that a major section of the downstream shell of the dam was moving (Figure 1).

to assist implementing emergency repairs. GA interpreted the failure mechanism as lateral basal sliding on a weak colluvial layer underlying the dam (GA 2000 & 2001). LEQ interpreted the failure mechanism as sliding along the interface of a layer of geotextile between the dam fill and the underlying colluvial clay due to a low interface friction angle (LEQ 2000). The correspondence indicates considerable professional debate between the two consultants regarding the failure mechanism. In-situ field shear testing of the colluvial clay, conducted by VCL in 2003, indicated a significant loss of shear strength upon saturation. Seepage models indicate that the foundation clays beneath the Cerro Santa Rosa tailings dam are indeed saturated (VCL 2004). Therefore, it is probable that the colluvial clay lost shear strength as it saturated, due to seepage from the impoundment. Once the shear strength of the colluvial clay decreased past its critical value a sliding block failure occurred through the clay.

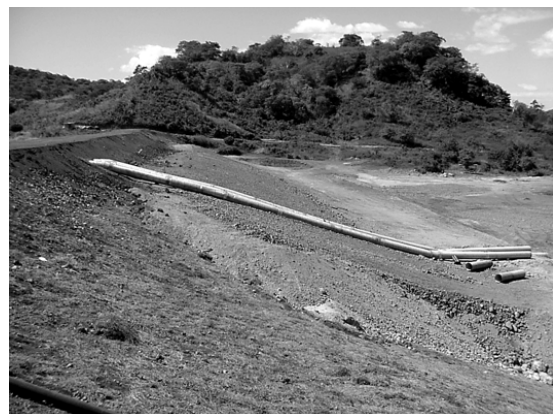
Figure 2. Emergency berm constructed along the downstream face of the Phase II dam following slope failure.

Emergency actions taken in October 2000 to mitigate dam movement consisted of stripping the vegetation and surficial soils downstream of the dam and constructing a blanket drain, a 3.5-m high toe berm, and a “wedge” of fill material atop the berm and against the downstream dam slope (Figure 2). The stabilization berm and “wedge” stopped the active movement of the dam. In addition, inclinometers and piezometers were installed to monitor the performance of the dam. GA made preliminary recommendations for a Phase III dam raise to crest elevation 92 m, which included excavating and removing the weak colluvial layer in the valley downstream of the dam and keying a substantial toe berm into residual bedrock.

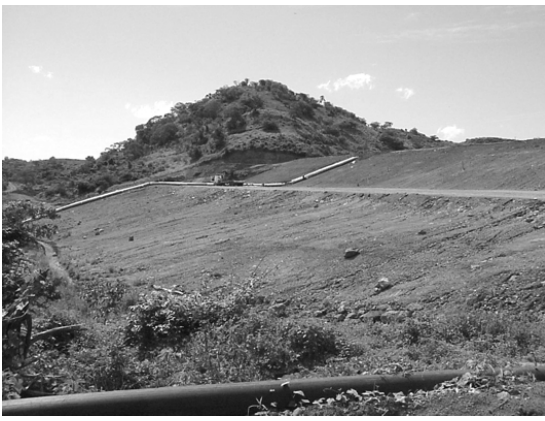
Figure 3. Cerro Santa Rosa tailings dam following construction of the Phase III downstream crest raise.

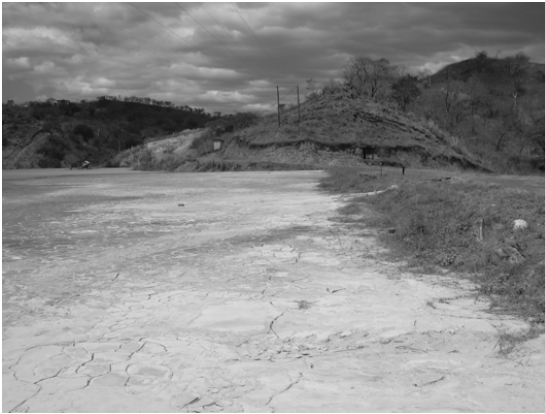
Figure 4. Condition of the Cerro Santa Rosa TDF in March 2004.

In February 2004 the dam was at an approximate crest elevation of 89 m, the pond elevation was approximately 88.1 m, and the tailings surface was at an approximate elevation 87.9 m. Given a historical tailings surface rate of rise of 2 m/yr only 6 months of operational tailings storage capacity existed with no storage reserve for stormwater retention, (Figure 4). Figure 5 presents a cross-section of the Cerro Santa Rosa Tailings dam and delineates the Phase I

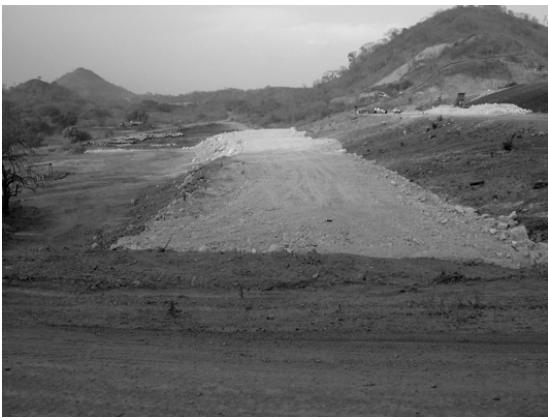
Figure 9. View of the Phase IV keyway/toe buttress.

Construction of the keyway and toe buttress was completed on 14 April 2004 (Figure 9). Completed in parallel with those activities was the construction of the drainage collection trench along the existing berm. Construction activities then focused on constructing the downstream sand blanket drain and rockfill shell (Figure 10). Construction of the MSE crest raise could not begin since the required geogrid had not arrived on site. However, crest stripping and excavations of the crest key and abutment keys began on 21 April 2004 in anticipation of the arrival of the geogrid.

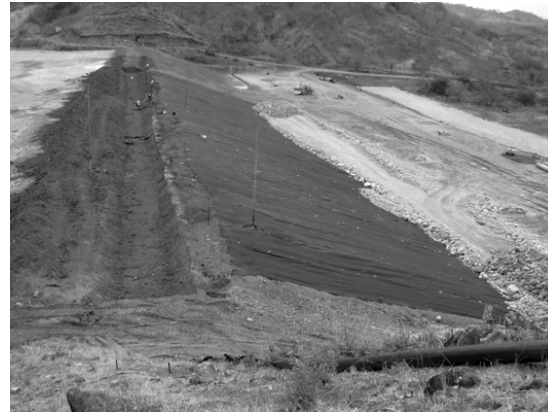
Figure 10. Construction of the sand blanket drain and downstream rockfill shell were completed as parallel tasks.

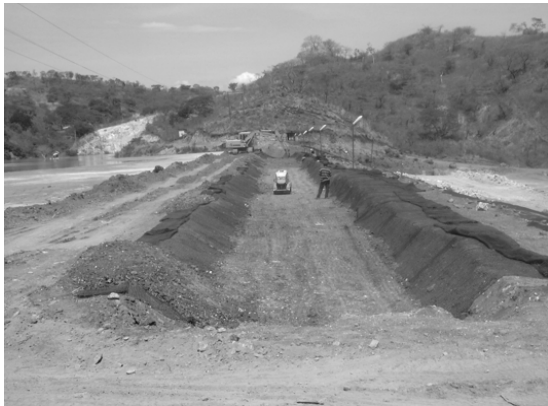
Figure 11. MSE wall construction began on 01 May 2004 with the first lift keyed into the Phase III crest.

The geogrid was delivered to the construction site on the afternoon of 30 April 2004. Construction of the first lift of the MSE wall began on 01 May 2004 (Figure 11), constructed in parallel with the downstream rockfill shell.

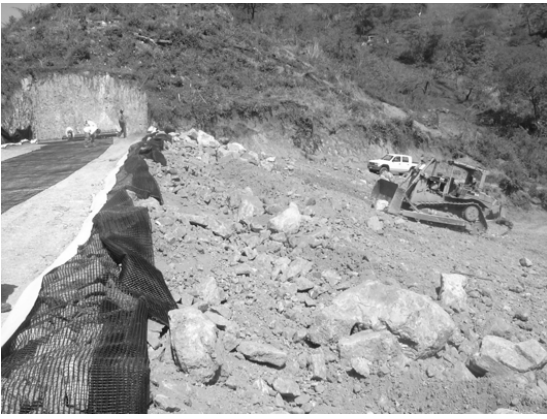
Figure 12. The downstream rockfill shell was raised at the same rate as the MSE wall.

MSE wall construction was brought to a halt at an elevation of 91 m due to the onset of the rainy season on 17 May 2004. Over the next week and a half, the remaining meter of MSE wall was constructed, and the Phase IV crest raise construction was officially completed on 27 May 2004 (Figures 12, 13 & 14).

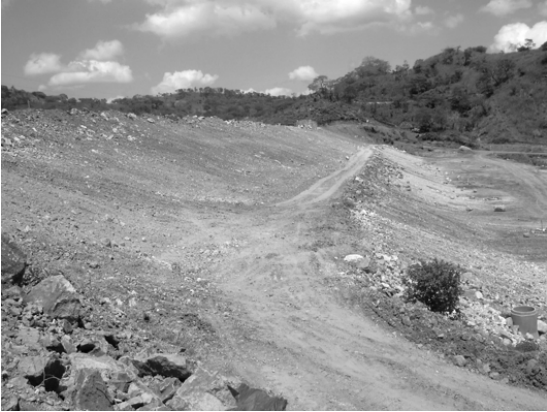
Figure 13. View of the completed Phase IV downstream rockfill shell.

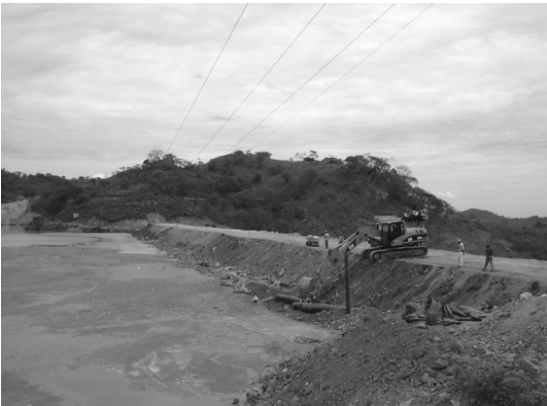
Figure 14. View of the completed Phase IV crest raise, looking downstream.
